Figure 1 Sketch of 1.5XLE (from GE literature).

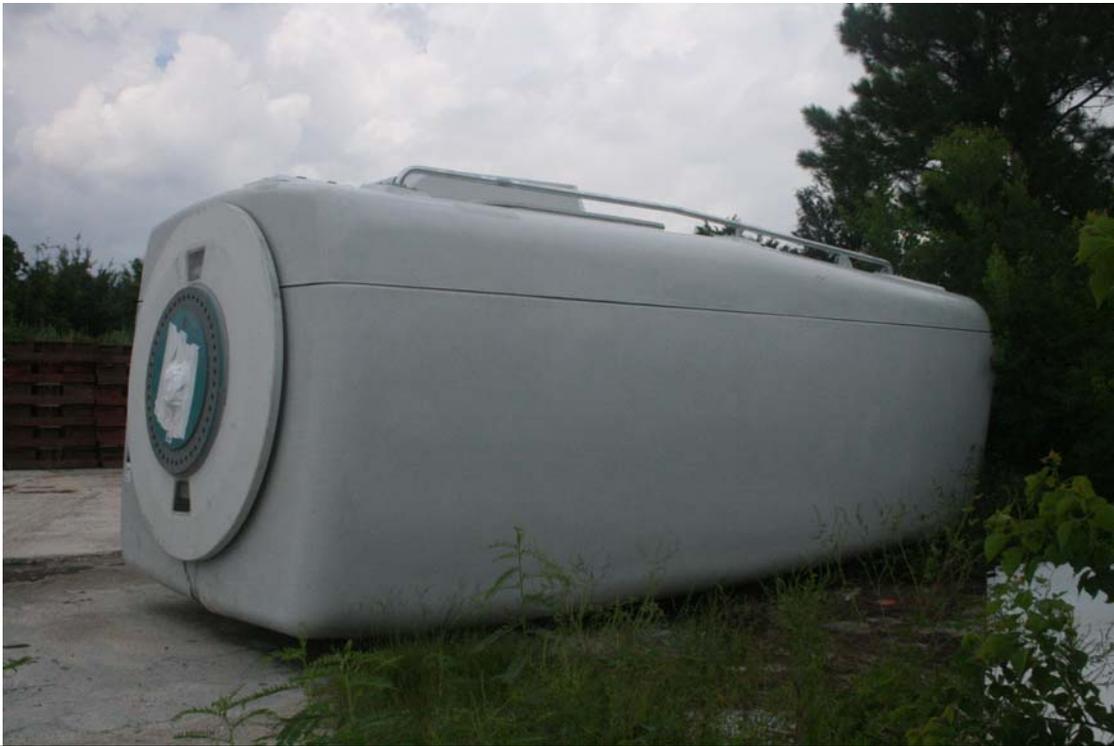
Figure 5 Left side of machine head.

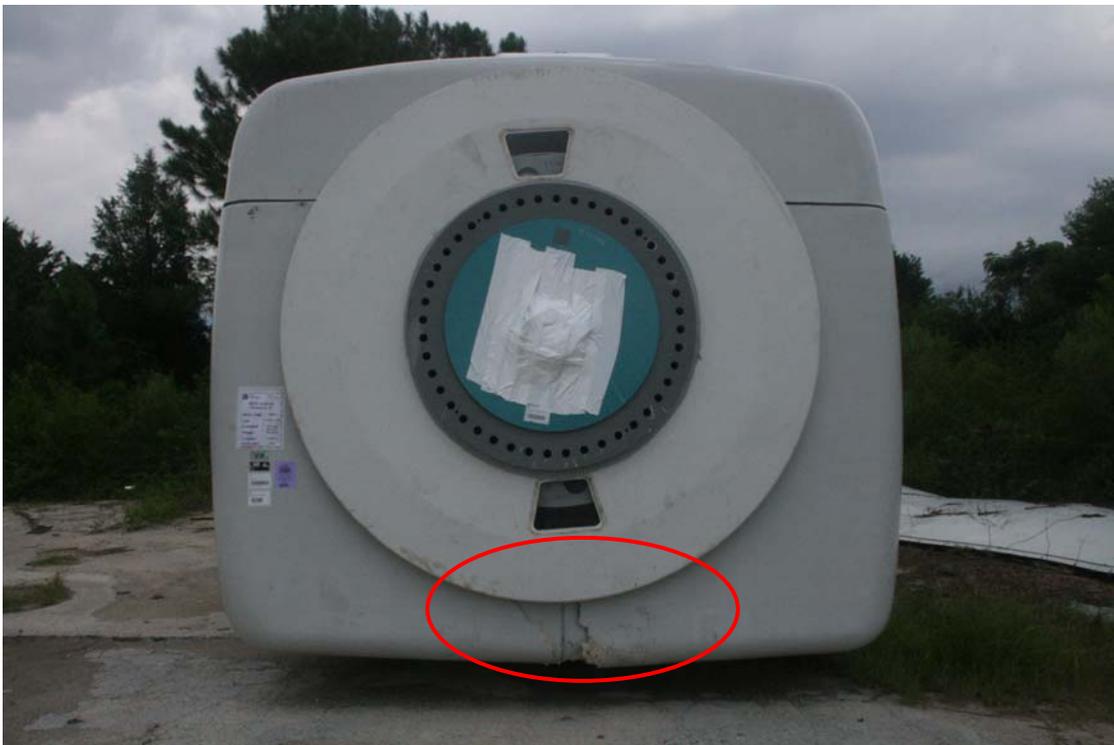
Figure 6 Front of machine head; nacelle fractured at bottom center.

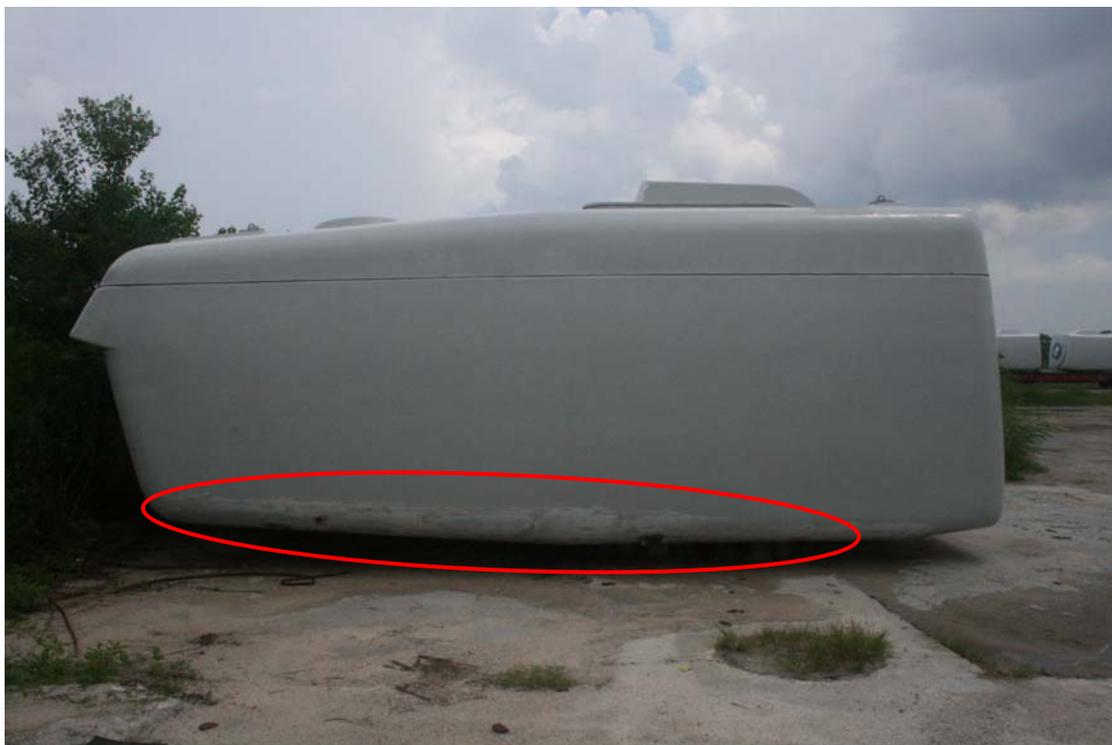
Figure 8 Right side of machine head with nacelle scrape marks and penetrations.

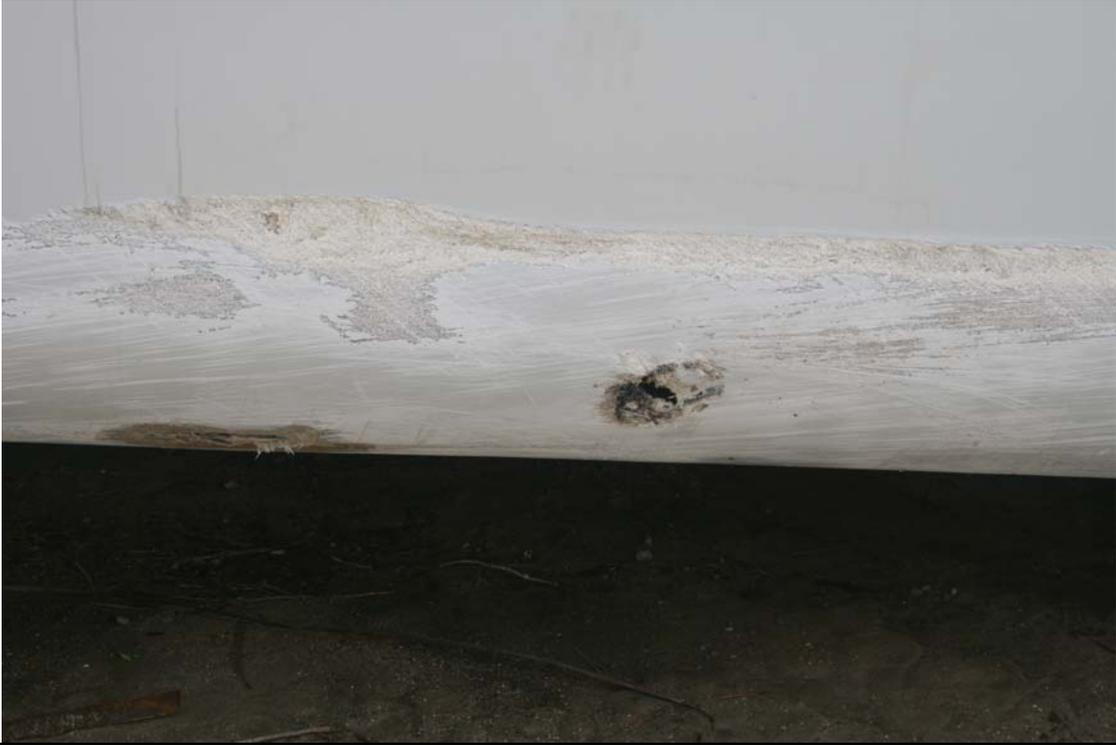
Figure 9 Penetration in nacelle near the right rear.

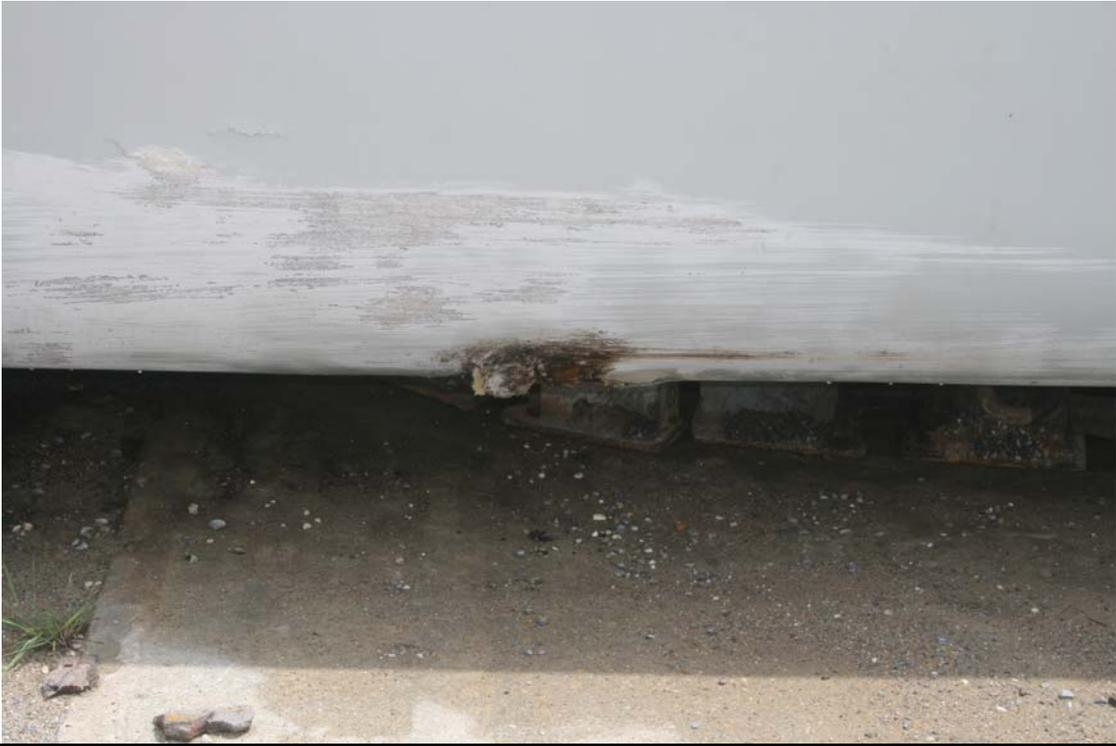
Figure 10 Penetration in nacelle right side near the center.

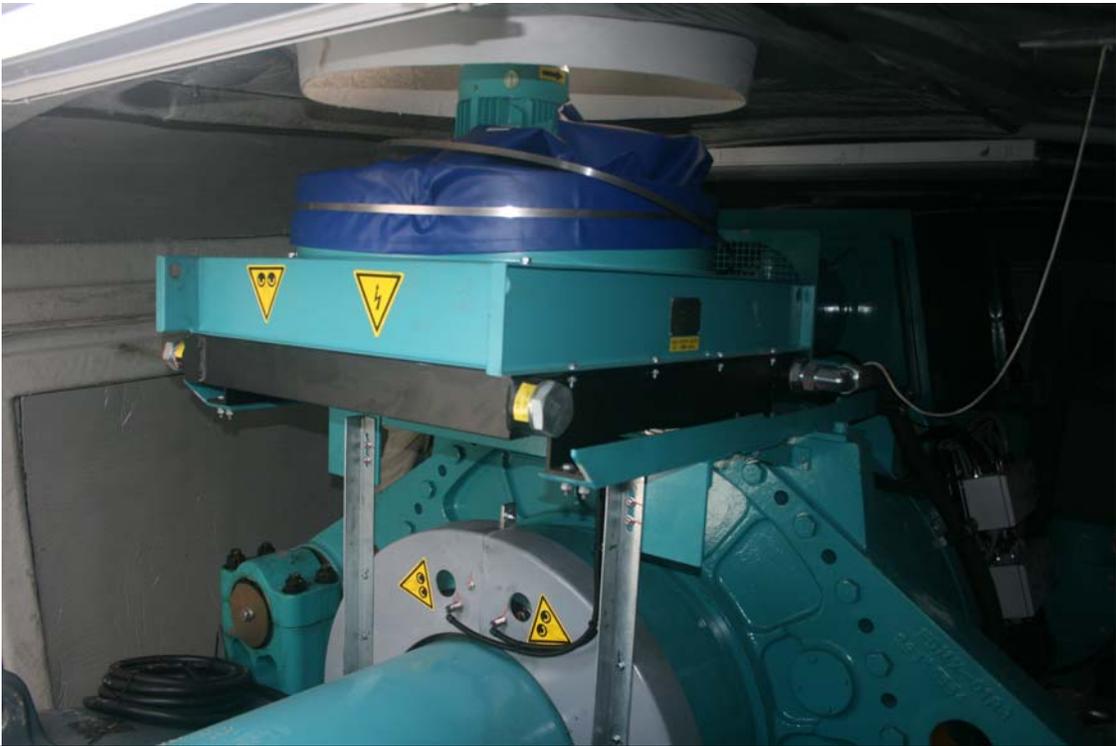
Figure 17 Oil cooler forward of gearbox with blue flex duct separated from nacelle.

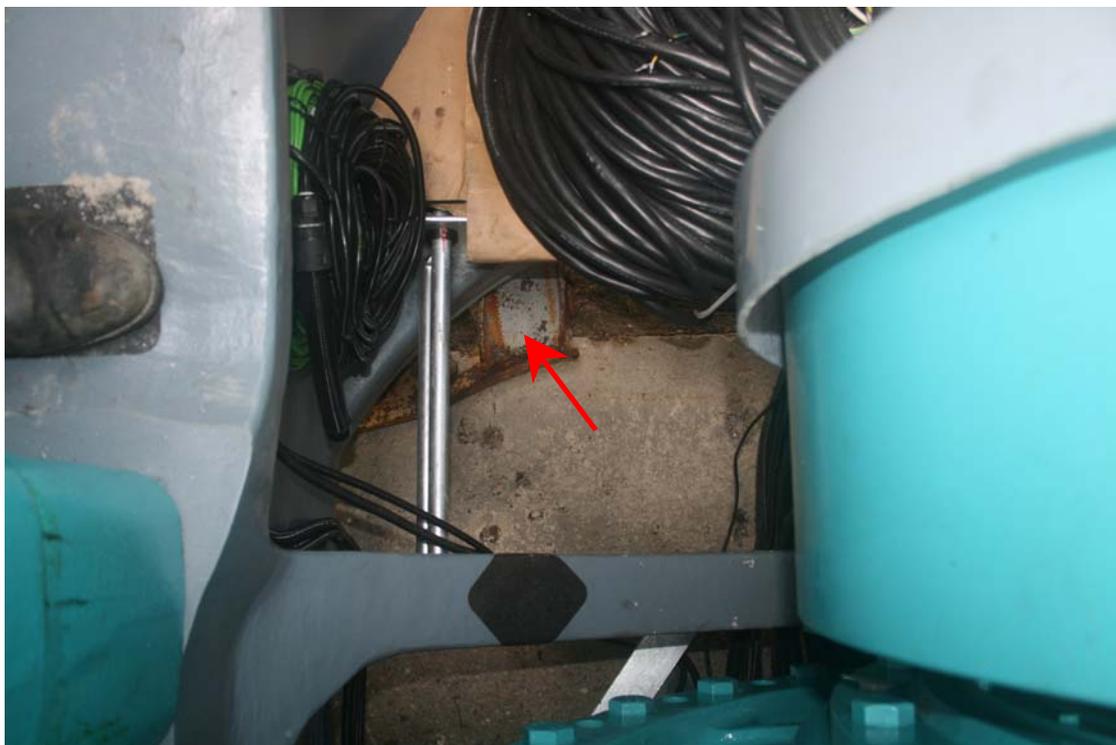
Figure 22 Tower cables coiled below main shaft. Bent shipping legs at arrow.

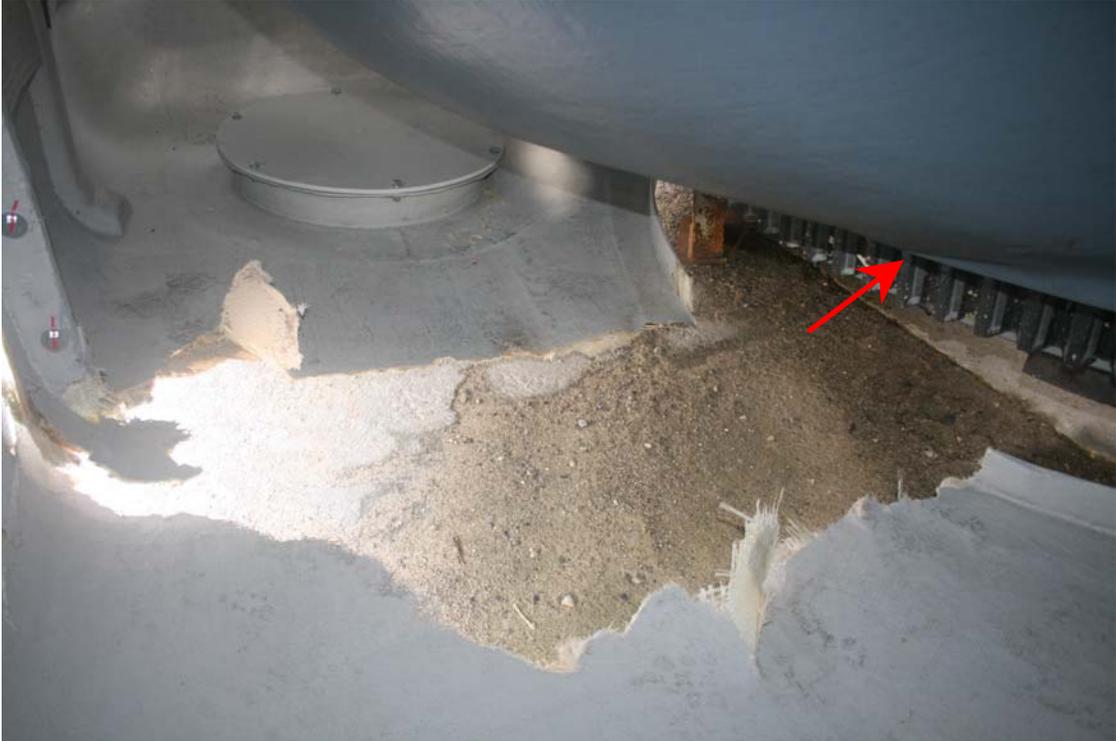
Figure 23 Fractured left front bottom of nacelle. Viewed to the front below the catwalk. Yaw gear at arrow.

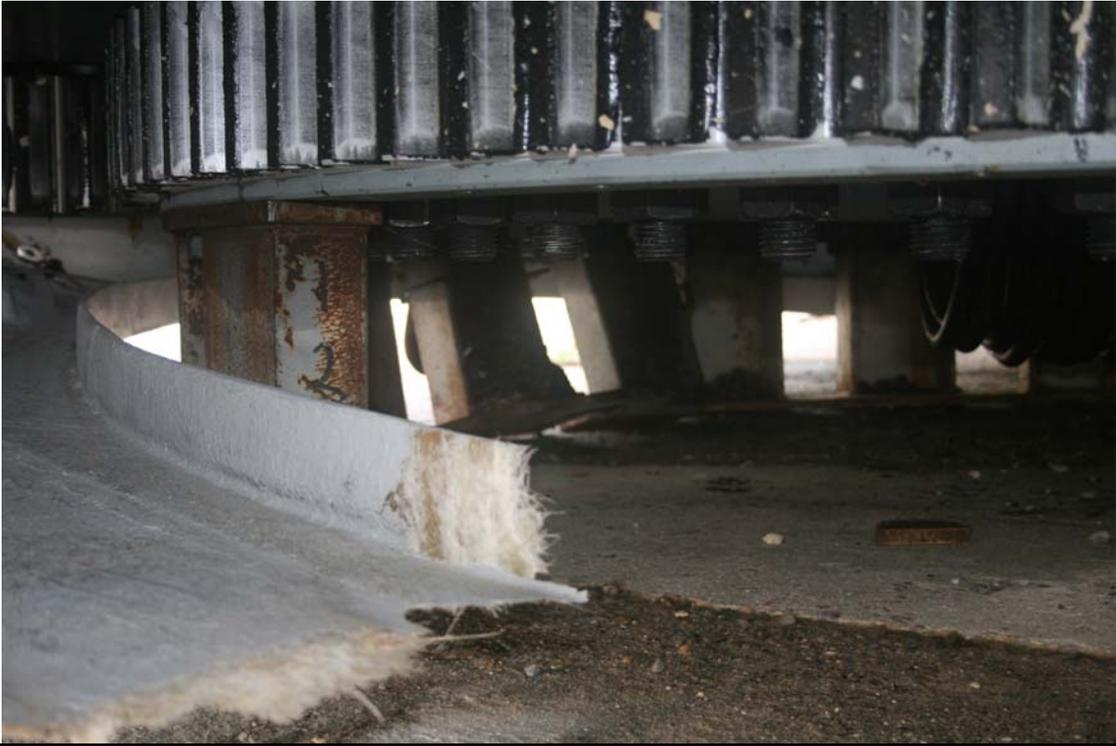
Figure 24 Bent shipping legs attached to the yaw gear.

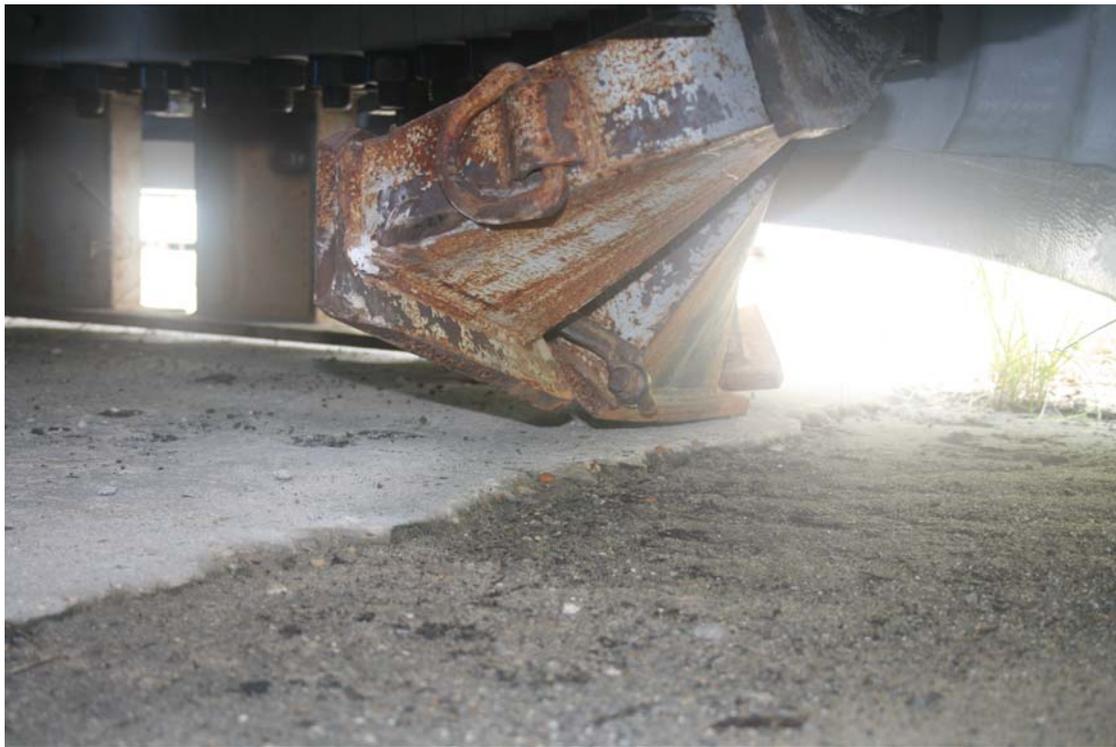
Figure 25 Bent shipping legs attached to the yaw gear.

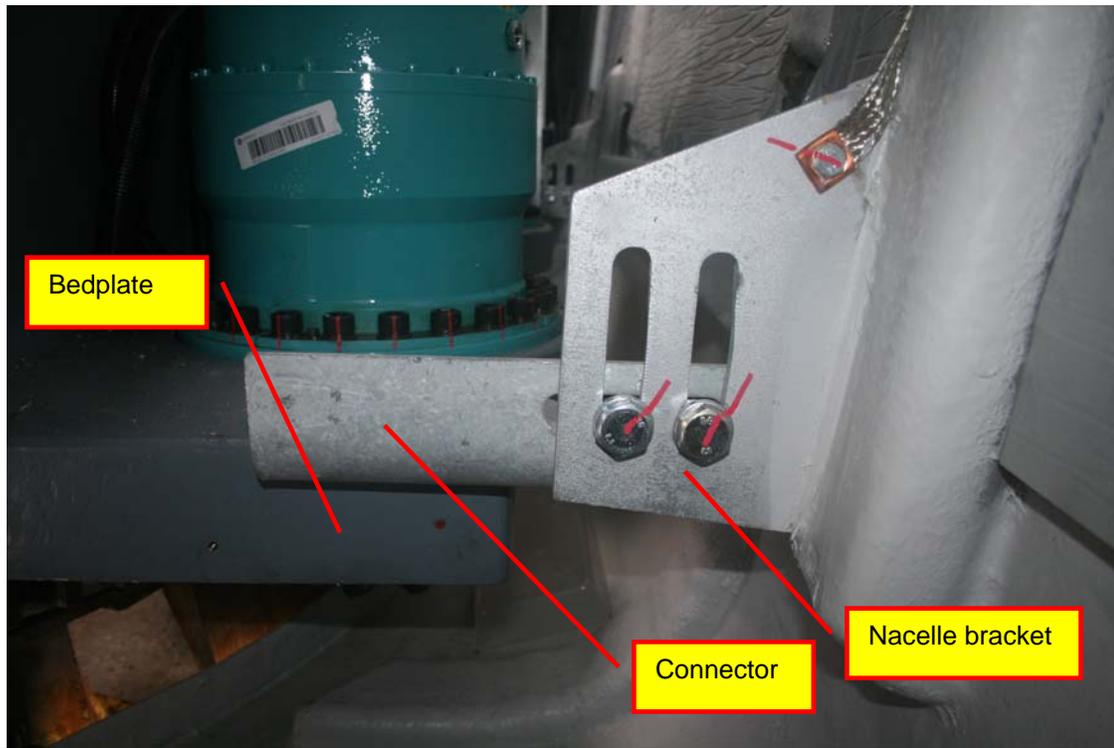
Figure 27 Left front nacelle attachment viewed to the rear. Bolting not moved.

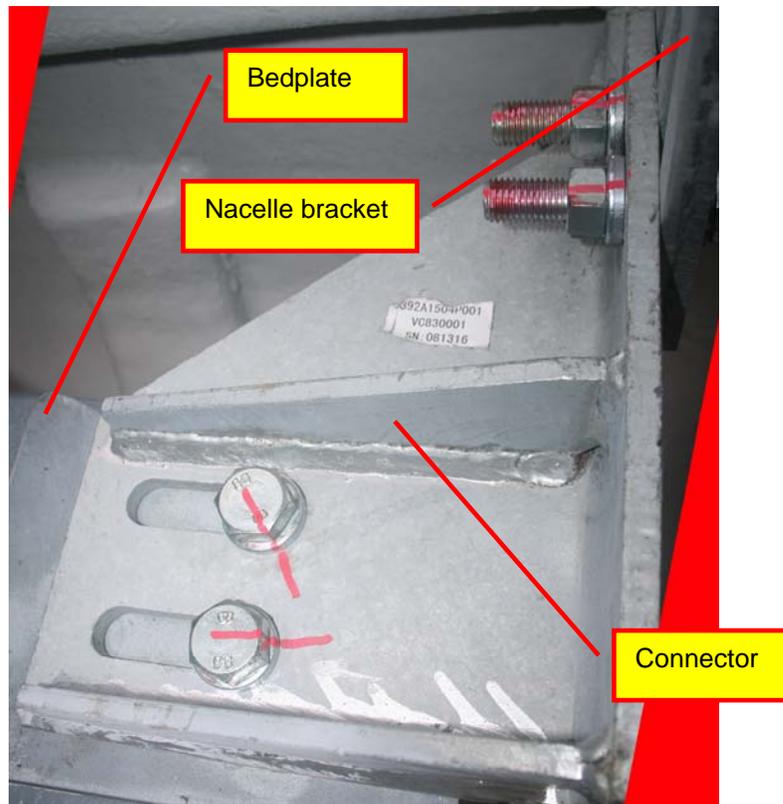
Figure 28 Left front nacelle attachment viewed from above. Bolting not moved. Connector not bent.

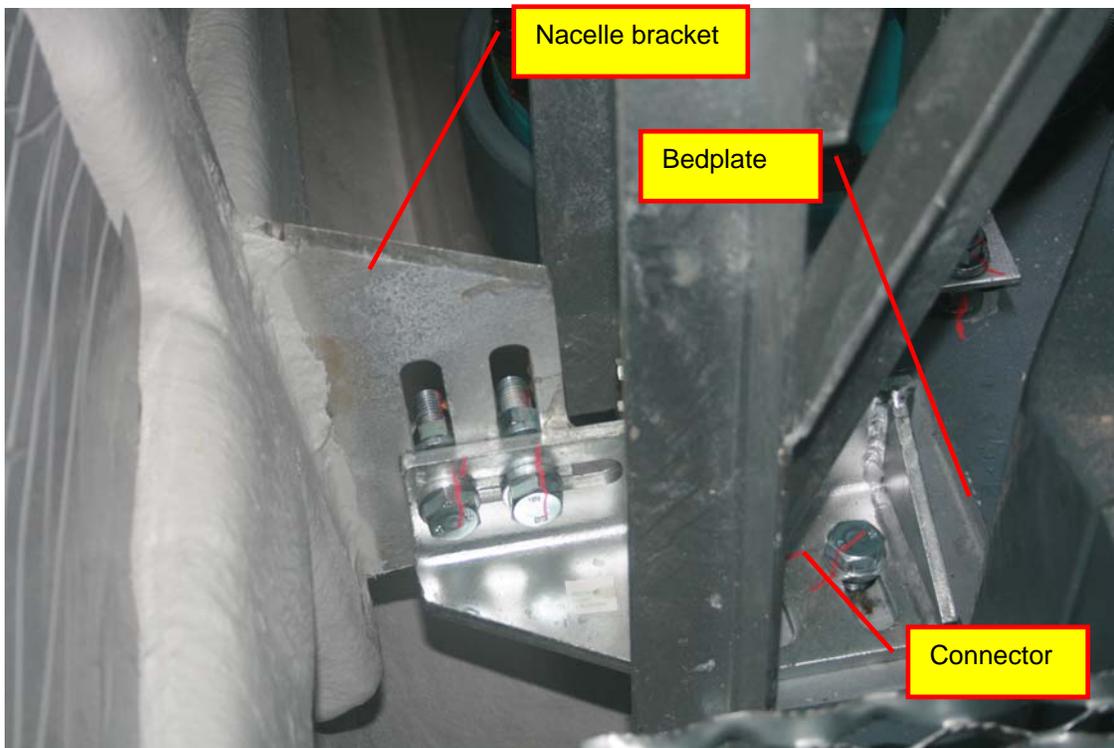
Figure 30 Left center nacelle attachment viewed from above. Bolting not moved. Connector not bent.

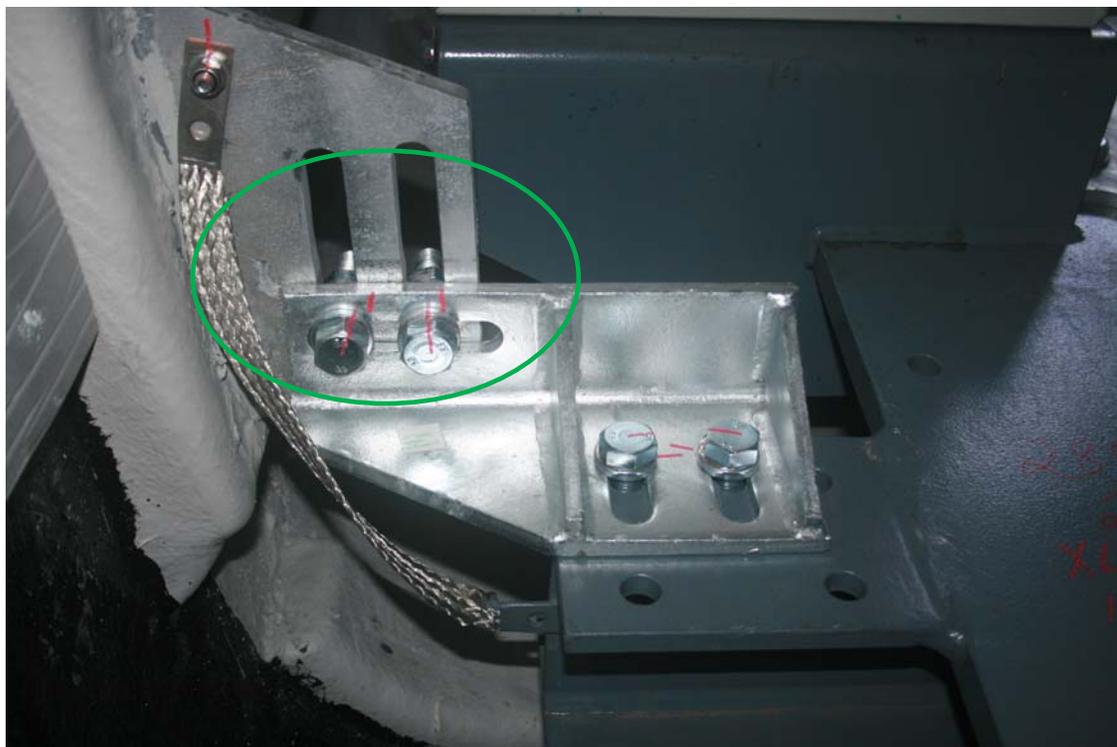
Figure 34 Left rear nacelle attachment. Bolting moved on nacelle end of connector.

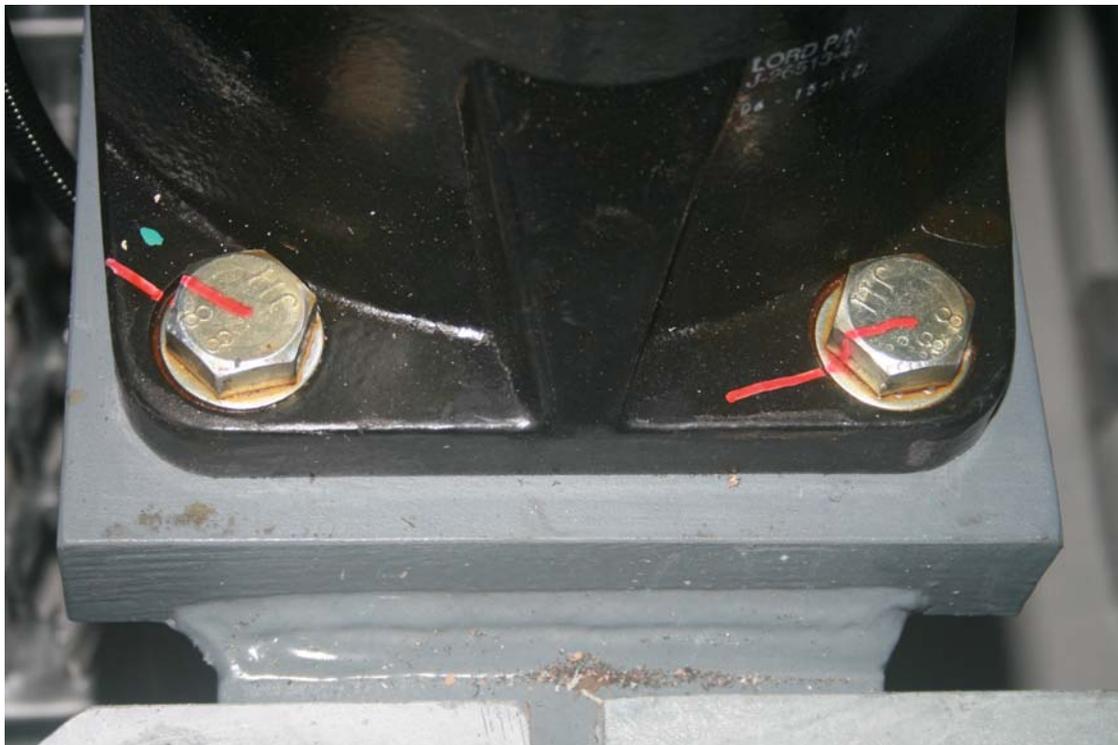
Figure 36 Left front generator mount. Generator frame attachment bolting not moved.

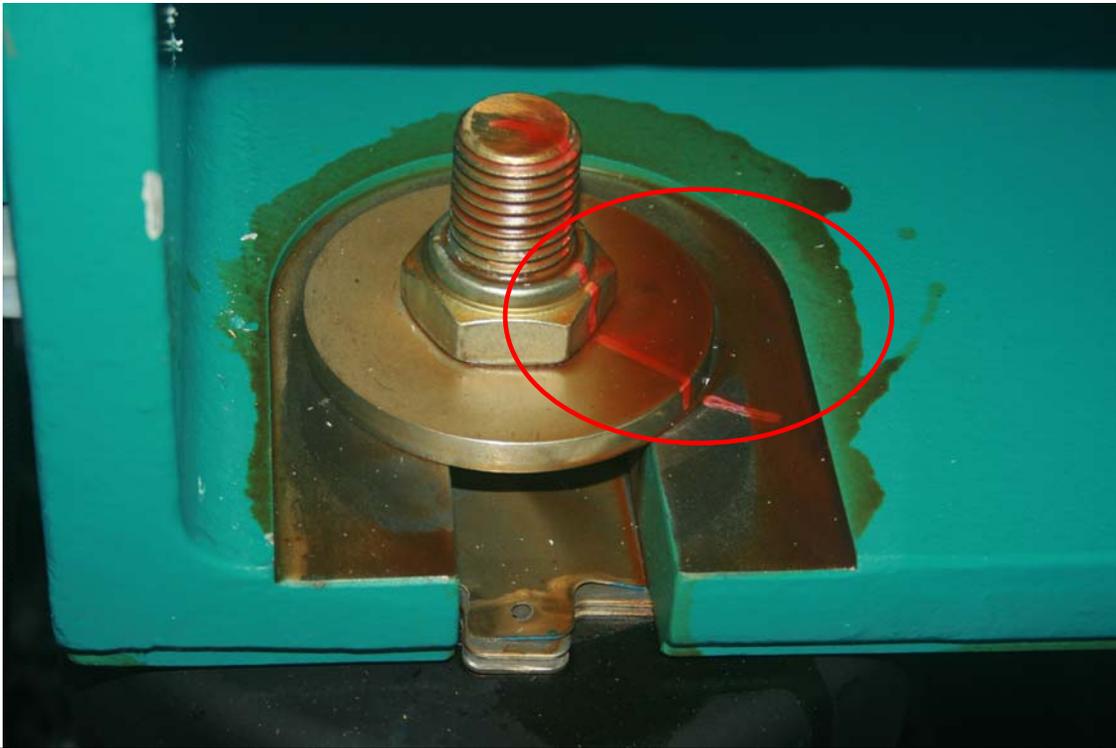
Figure 37 Left front generator mount. Elastomeric insert bolting moved.

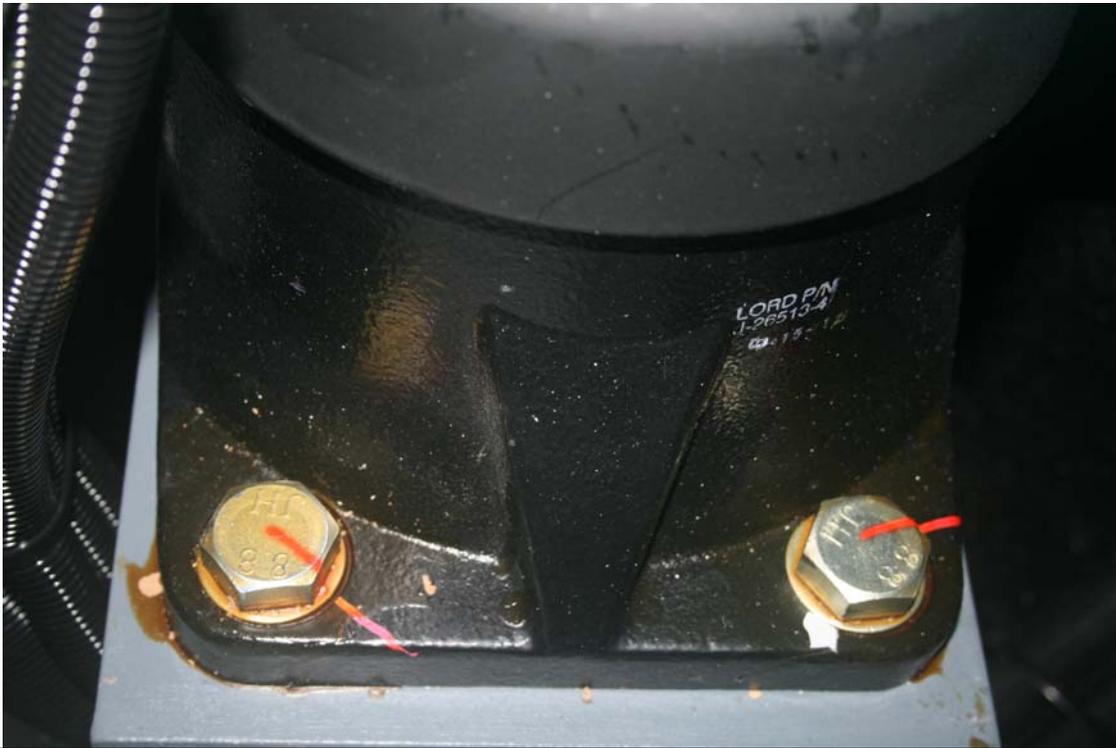
Figure 39 Left rear generator mount. Generator frame attachment bolting not moved.

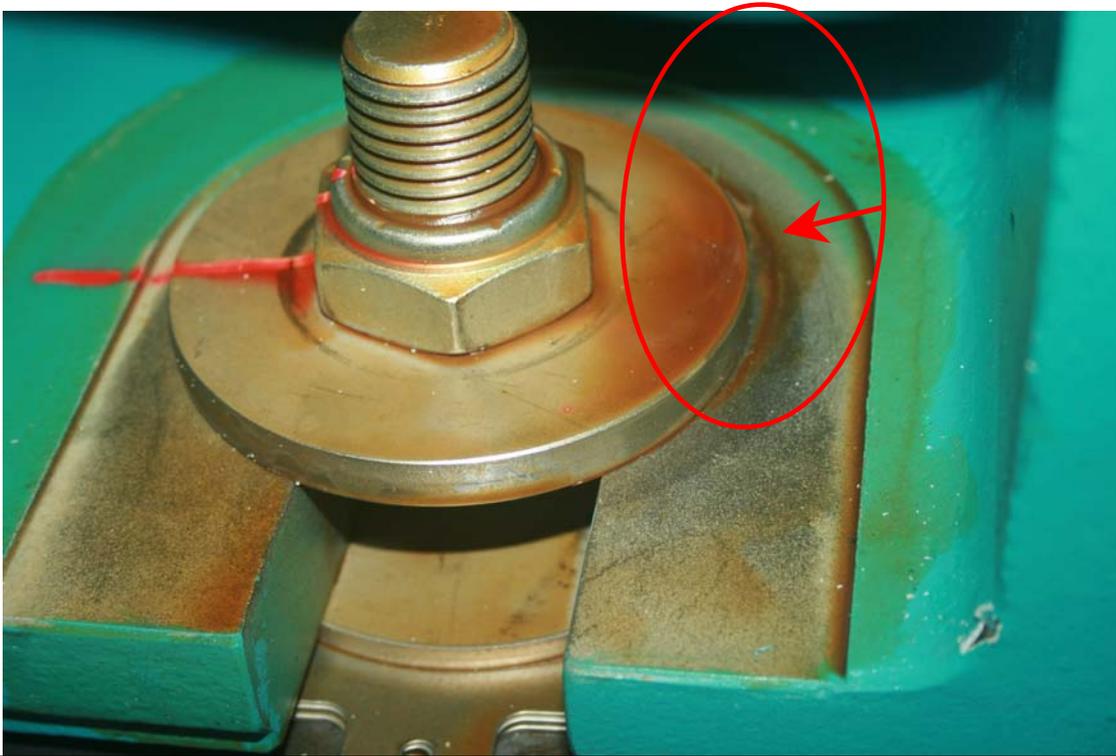
Figure 40 Left rear generator mount. Elastomeric insert bolting moved.

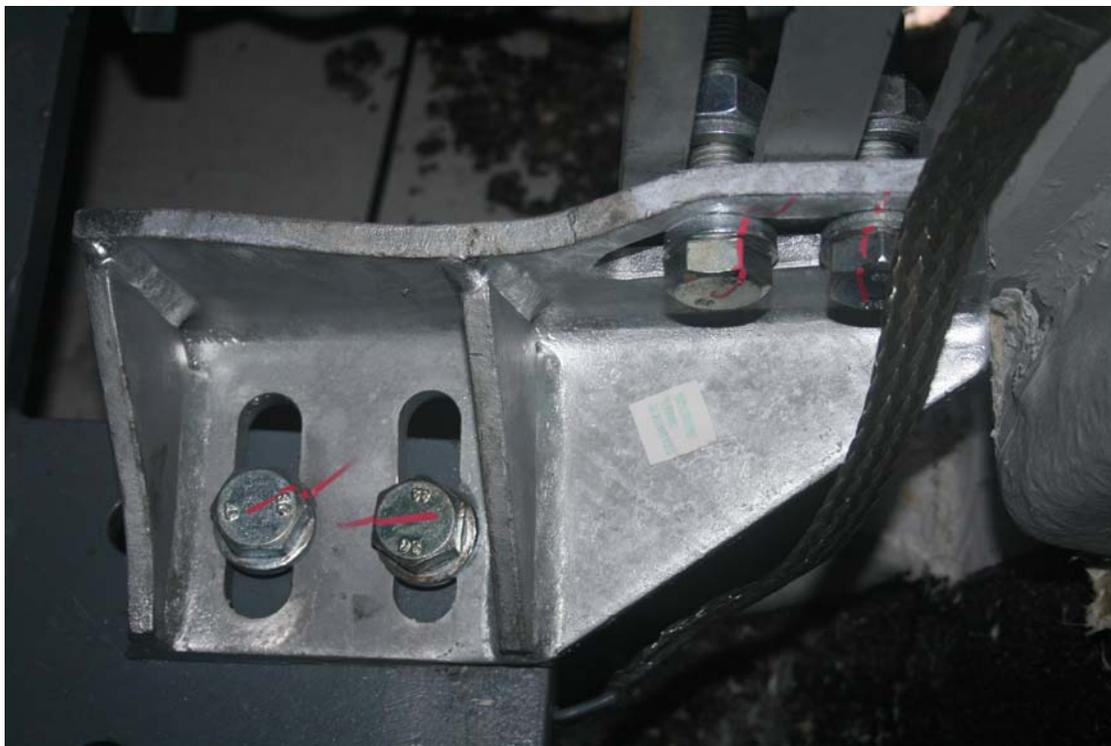
Figure 42 Right rear nacelle attachment. Connector bent. Nacelle bracket bolting moved.

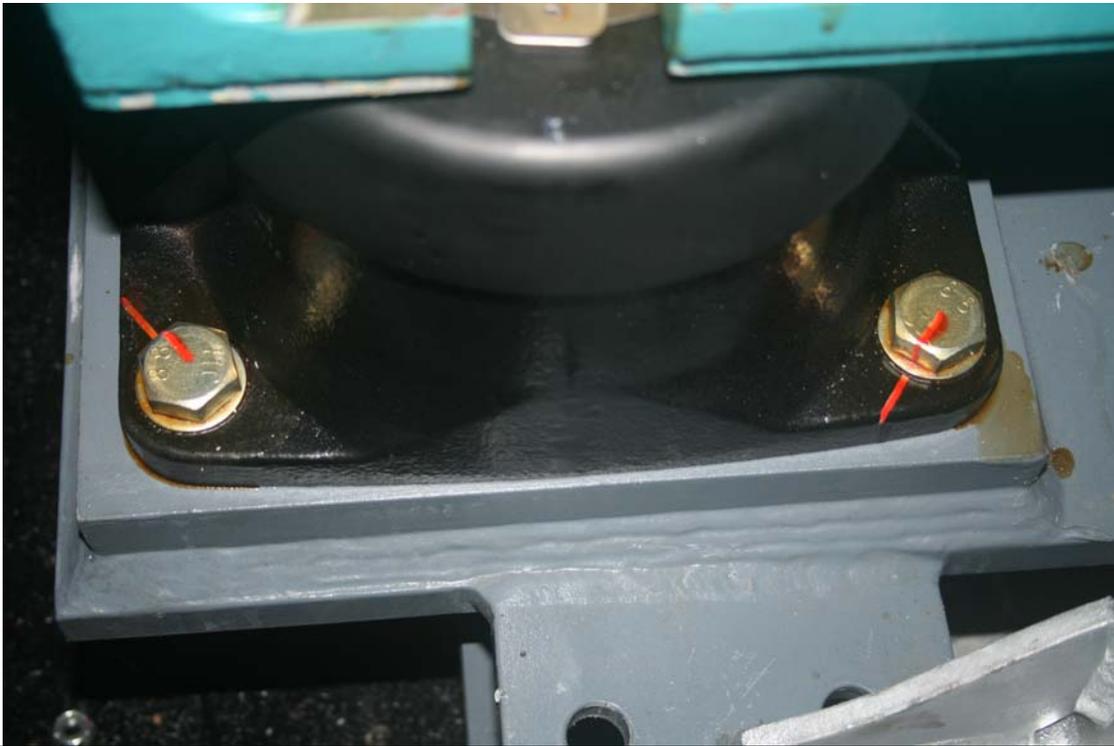
Figure 43 Right rear generator mount. Generator frame attachment bolting not moved.

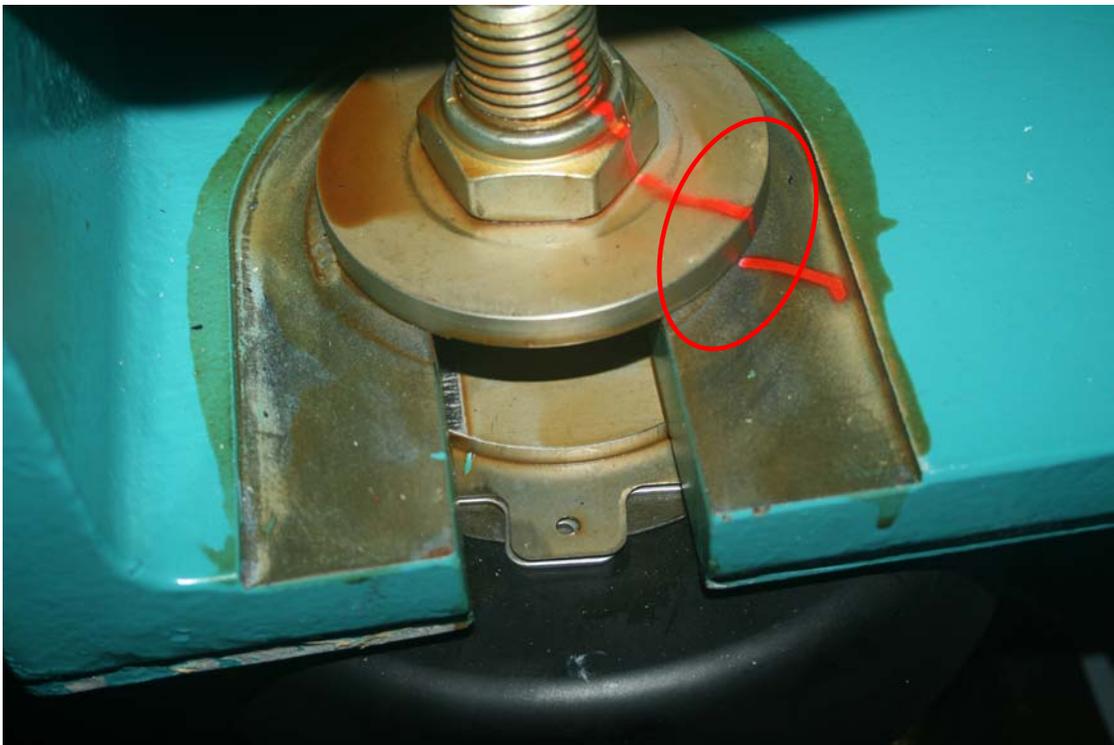
Figure 44 Right rear generator mount. Elastomeric insert bolting moved.

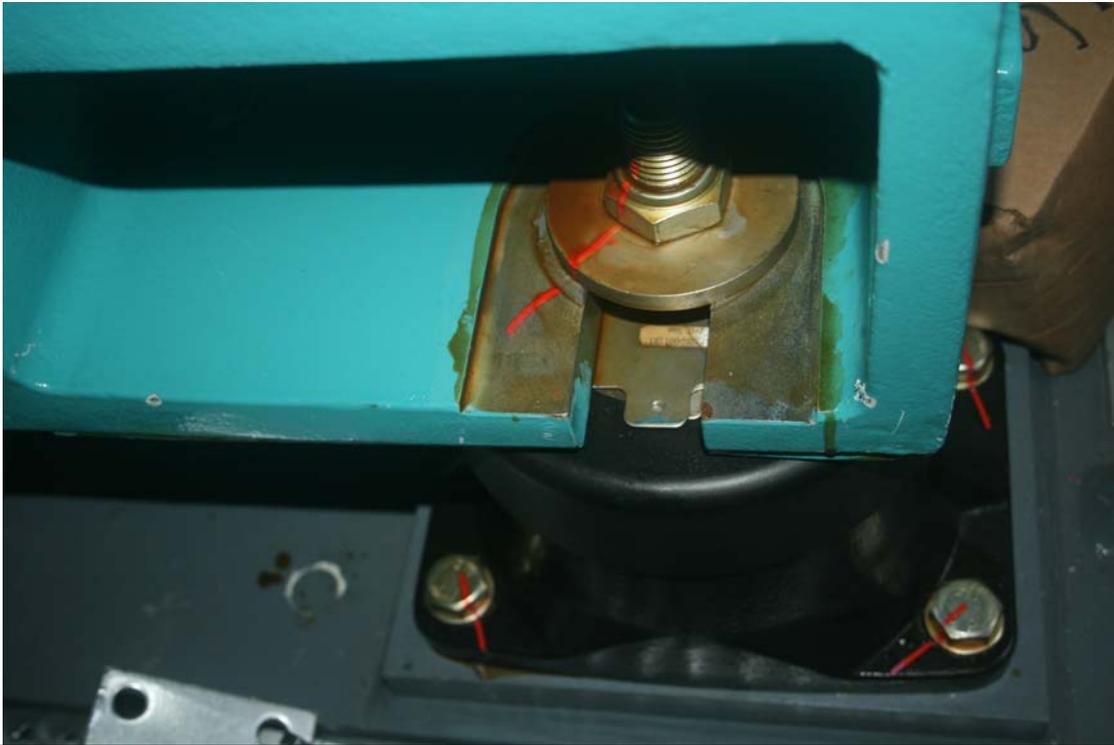
Figure 45 Right front generator mount. Generator frame attachment bolting not moved. Elastomeric insert bolting moved.

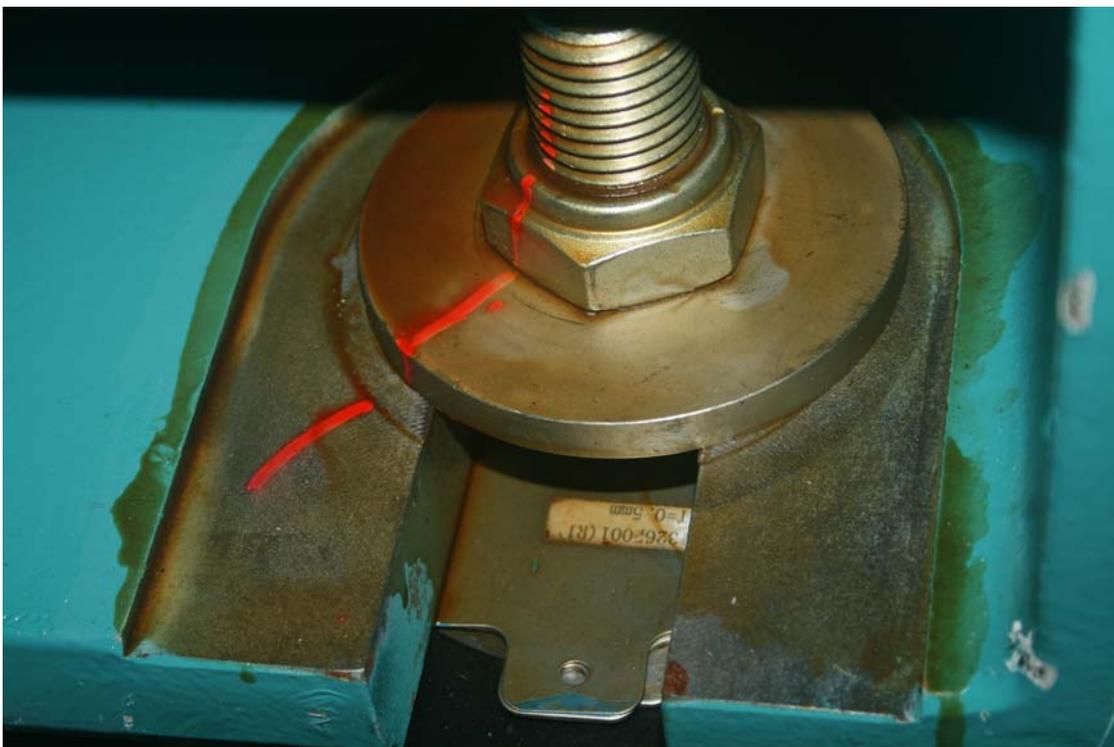
Figure 46 Right front generator mount. Elastomeric insert bolting moved.

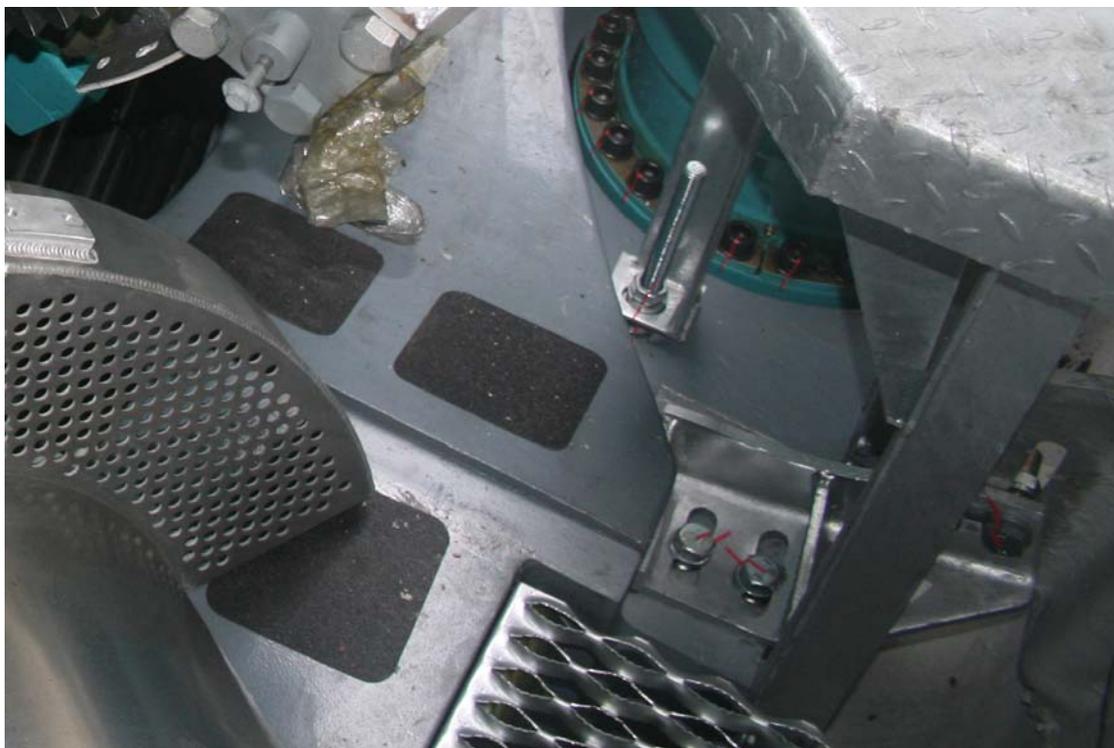
Figure 48 Right center nacelle attachment. Connector bent. Nacelle bracket bolting moved.

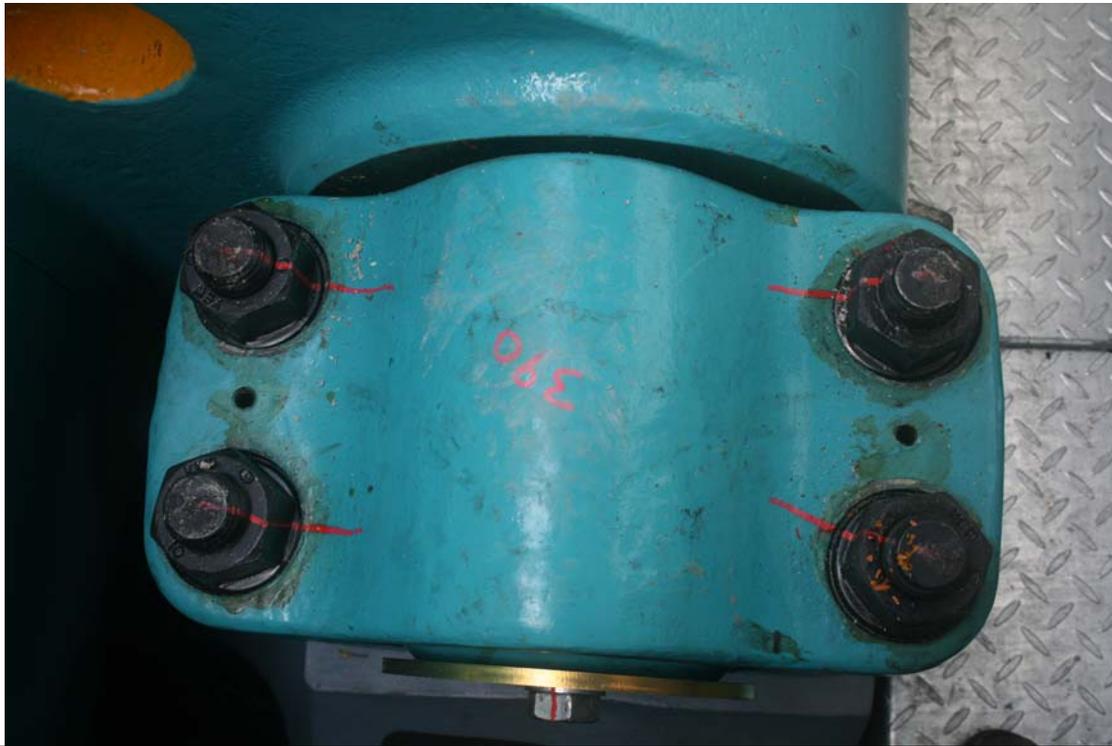
Figure 49 Right rear gearbox mount bolting. Typical of right front gearbox bolting.
